# Arboricultural Impact Assessment/Method Statement

Proposed Data Centre. Site  
at Moss Moran, Fife

23.07.2025

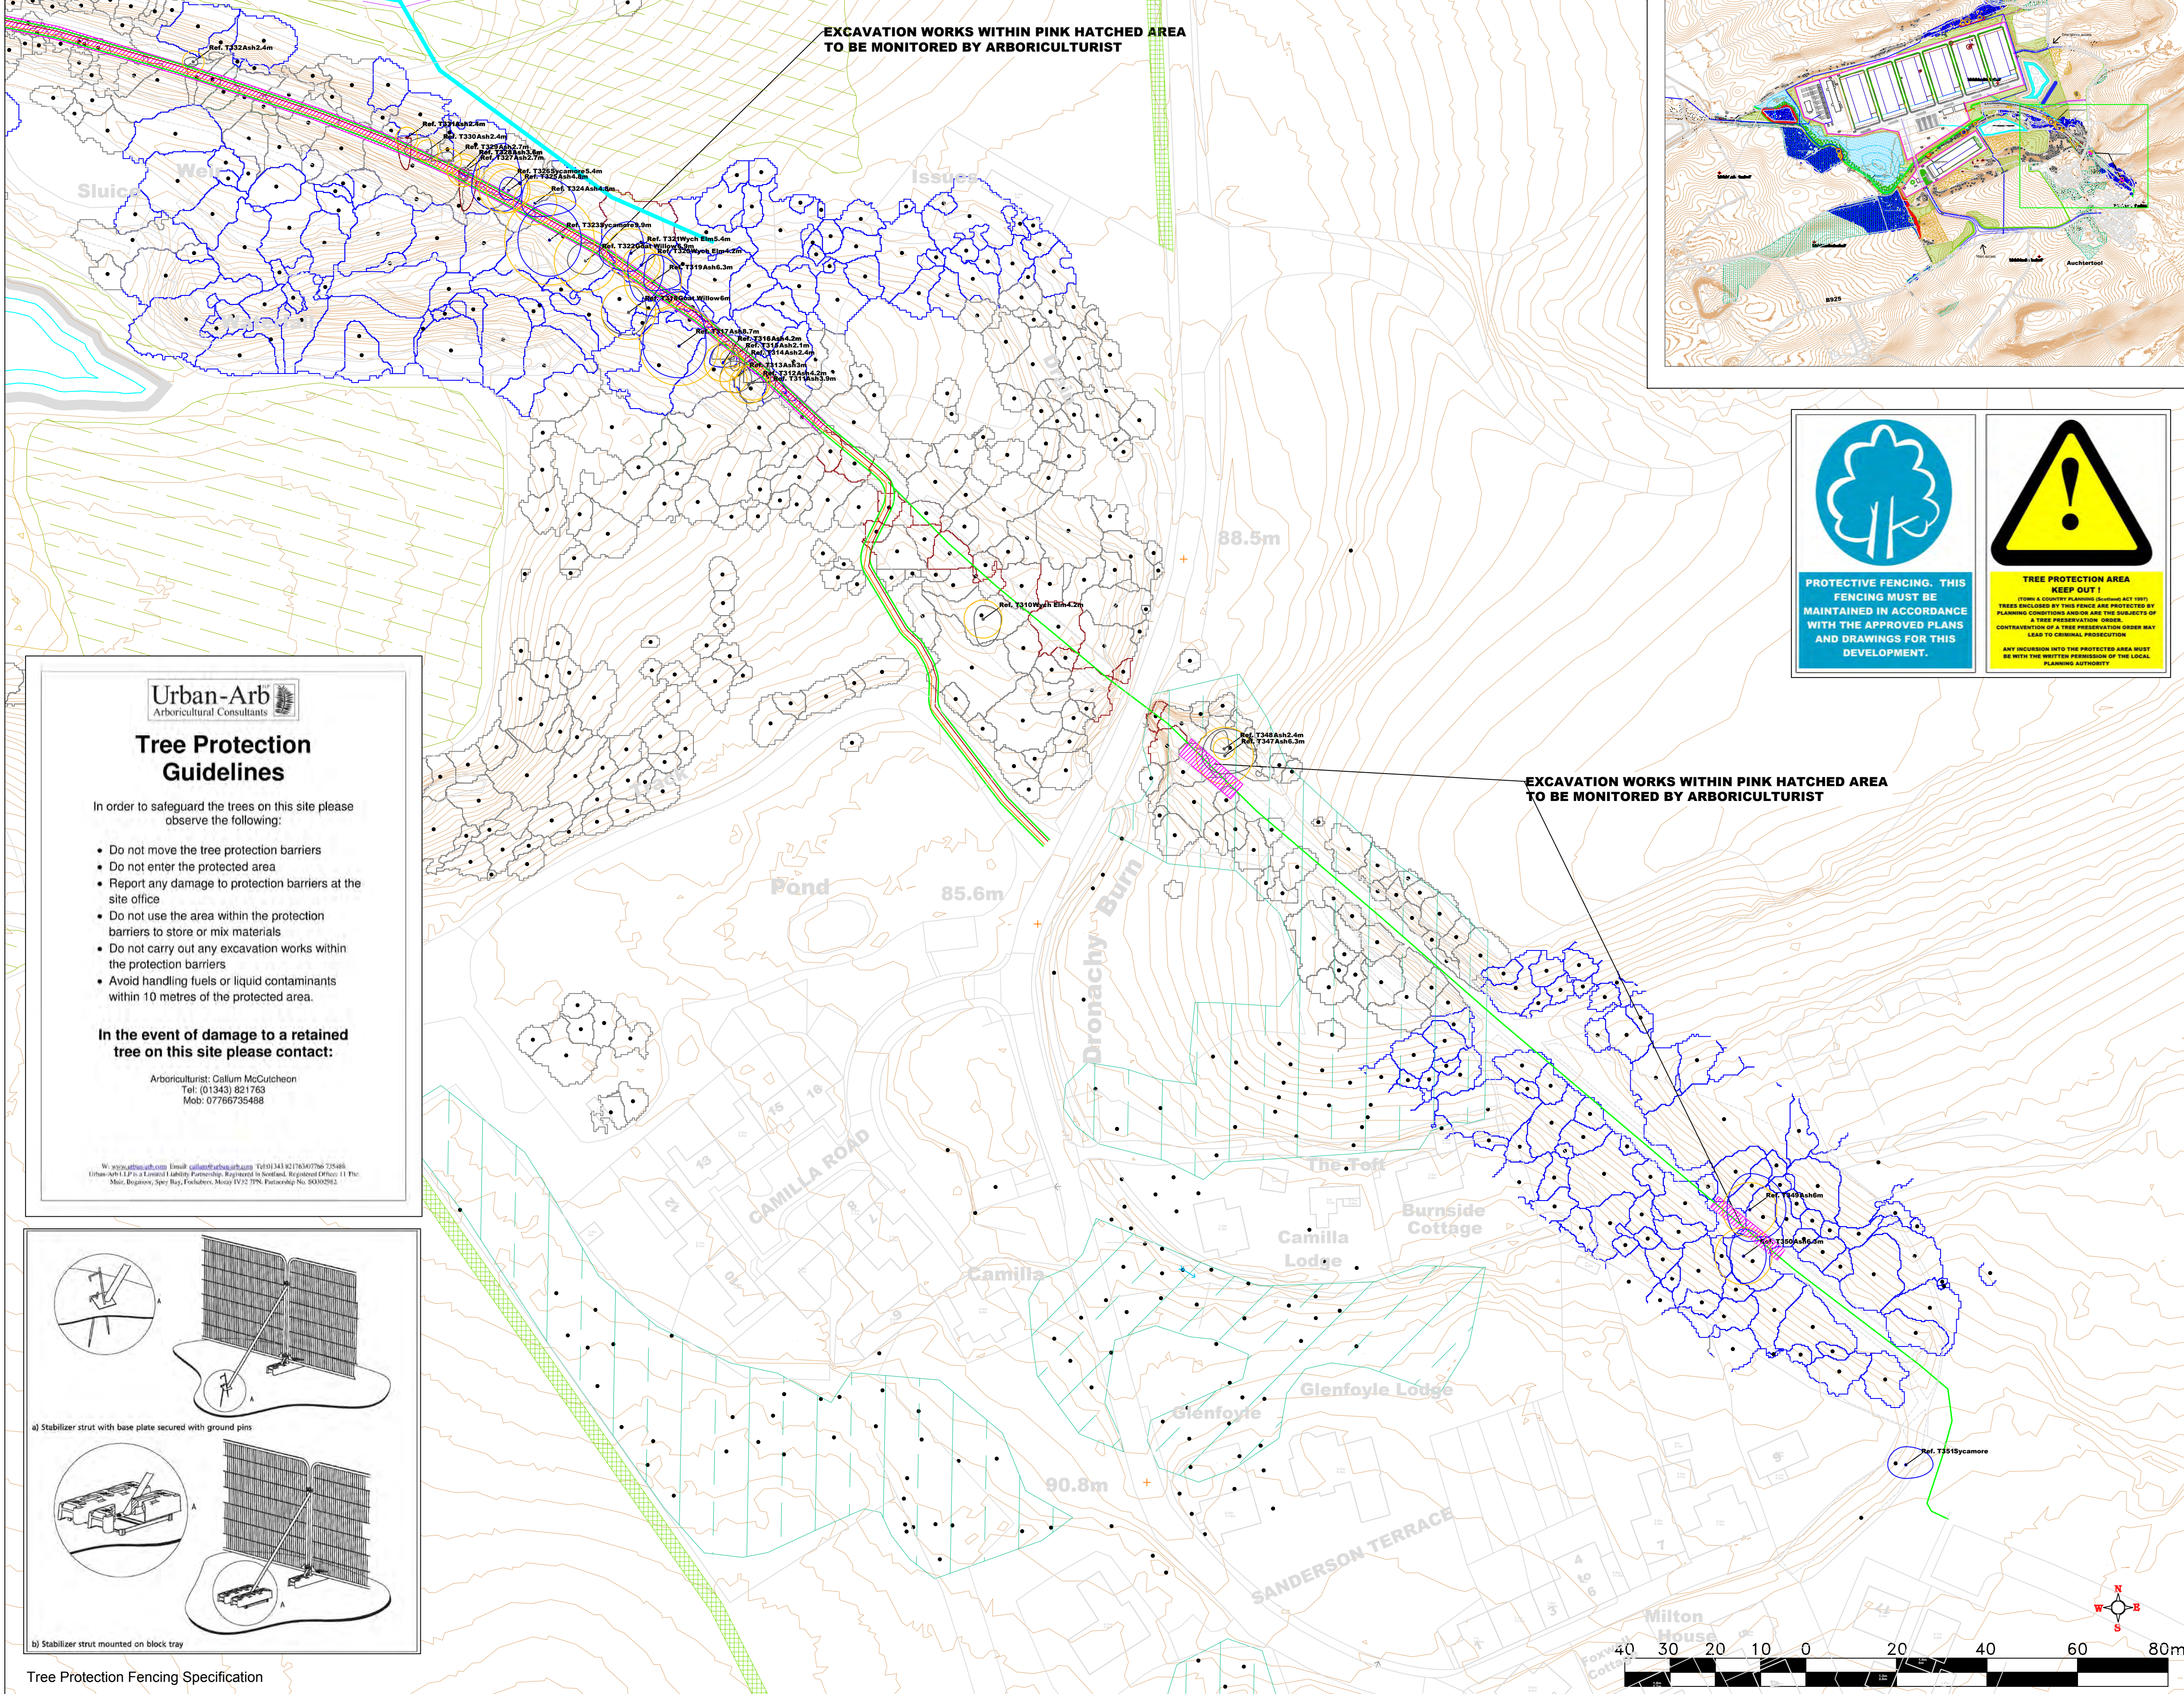
# Tree Protection Plan, Rev A

Root damage monitoring zone (See Arboricultural Method Statement)

EXCAVATION WORKS WITHIN PINK HATCHED AREA/  
TO BE MONITORED BY ARBORICULTURIST

CRONS OF SMALL SHRUBS TO BE  
TRUNKED BACK WHERE NECESSARY  
TO CLEAR PATH

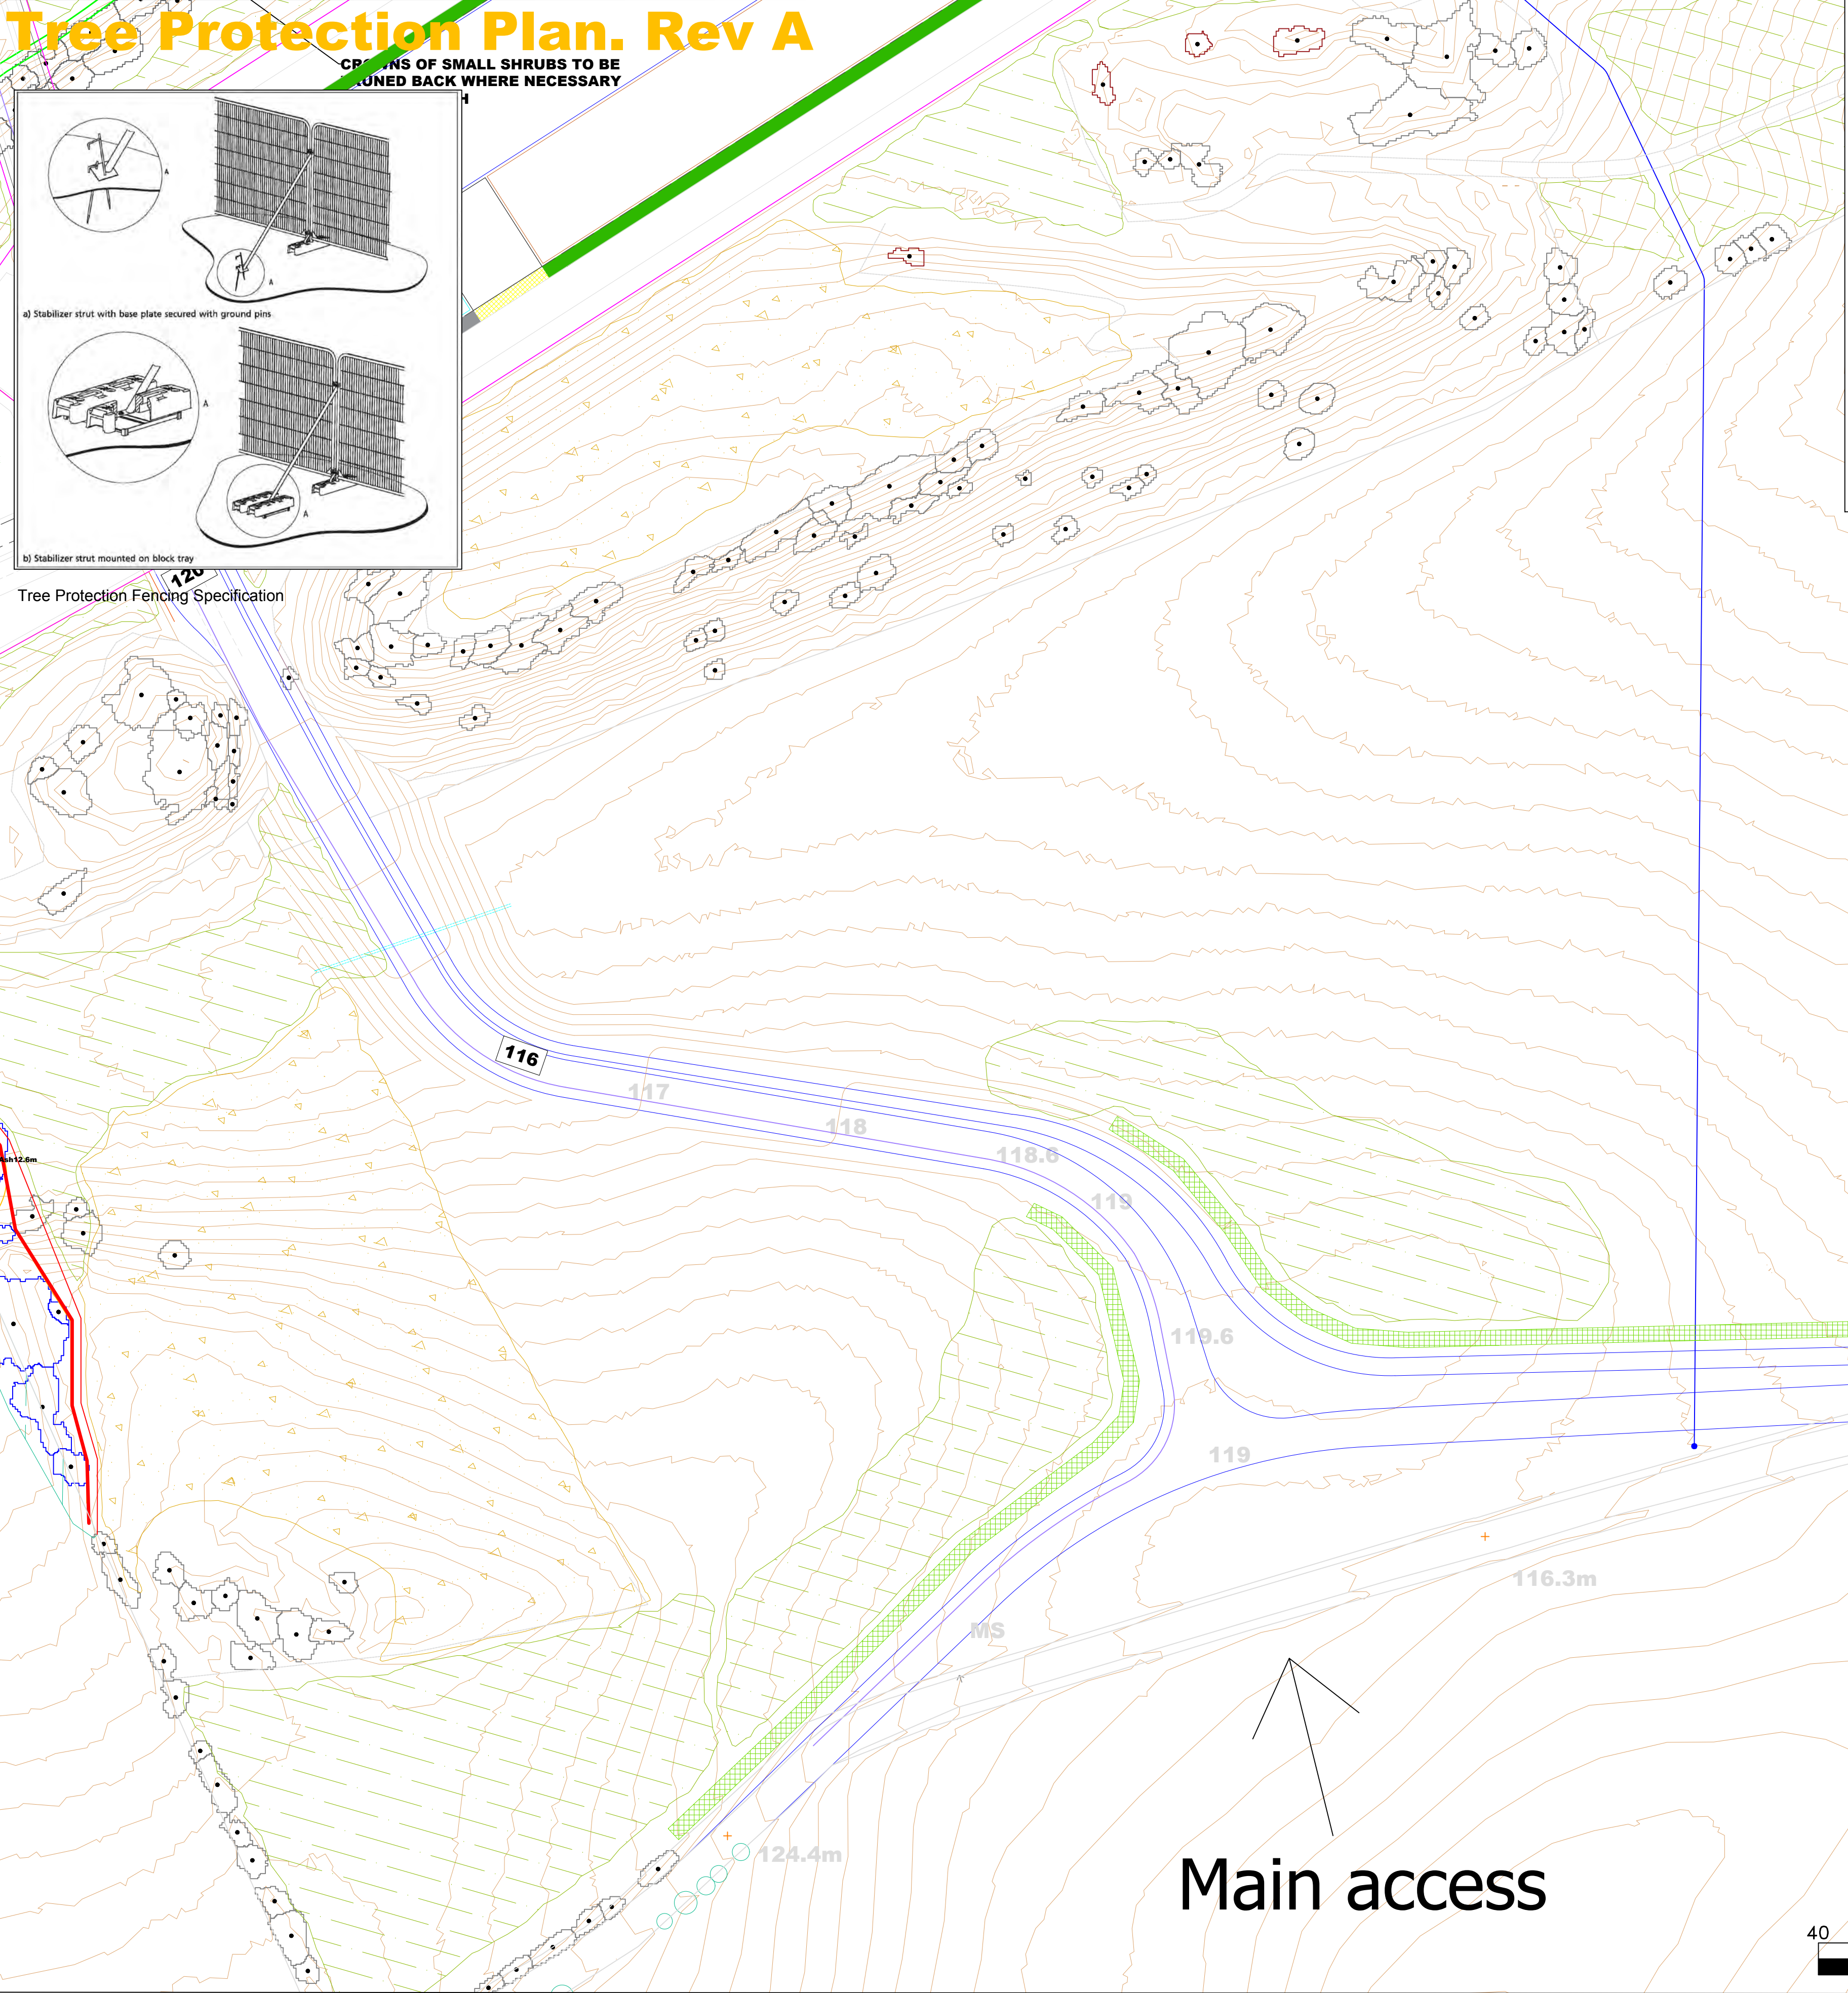
# Tree Protection Plan. Rev A

**Root damage monitoring zone (See Arboricultural Method Statement)**

CRONS OF SMALL SHRUBS TO BE  
PRUNED BACK WHERE NECESSARY
