## AUCHTERTOOL, MOSSMORRAN, FIFE

### STAGE 1 GEOENVIRONMENTAL INVESTIGATION REPORT INCORPORATING COAL MINING RISK ASSESSMENT (CMRA)

Our Ref: ZG116-01/DOP/SAG/TNO

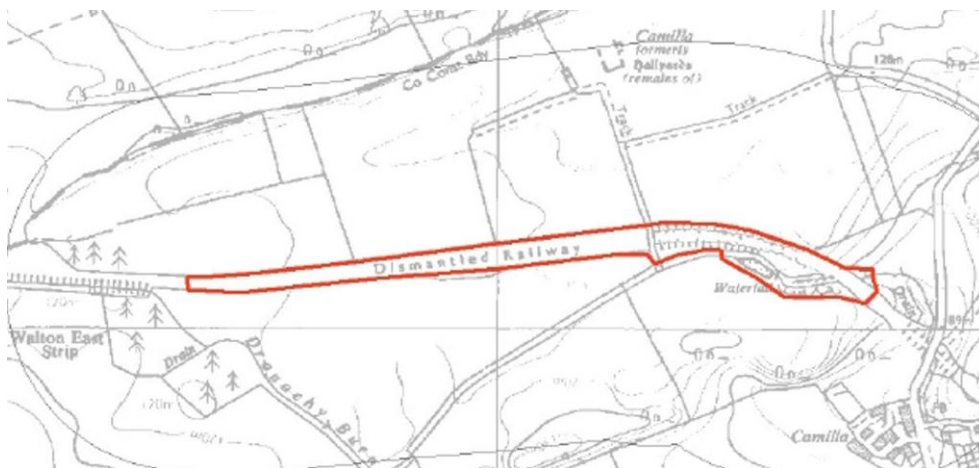
The researches have indicated that part of the former railway cutting within the site was infilled and utilised as a landfill. Fife Council have referenced that the nature of the infill material is indicated to comprise excavated soils, however it could contain biodegradable material and could degrade to produce elevated levels of gas including methane, carbon dioxide, hydrogen sulphide and carbon monoxide. Fife Council have indicated that the site was producing carbon dioxide.

Extent of railway cutting indicated to be utilised as a landfill (source Local Authority)

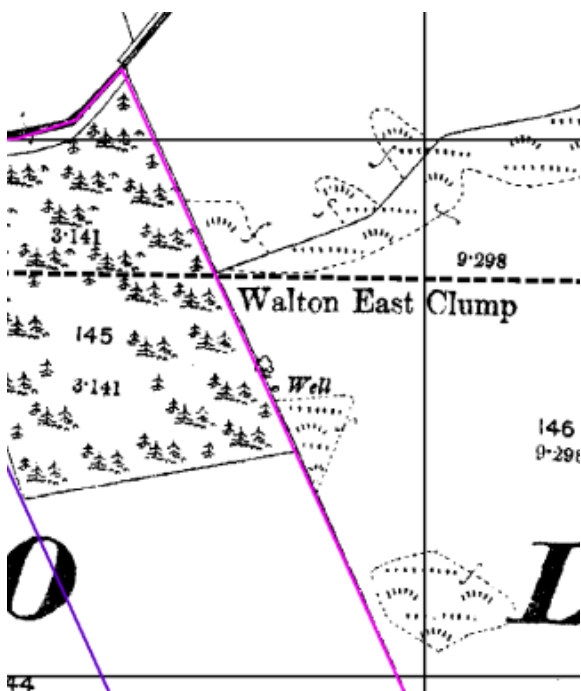
Former Well at the south-western site boundary

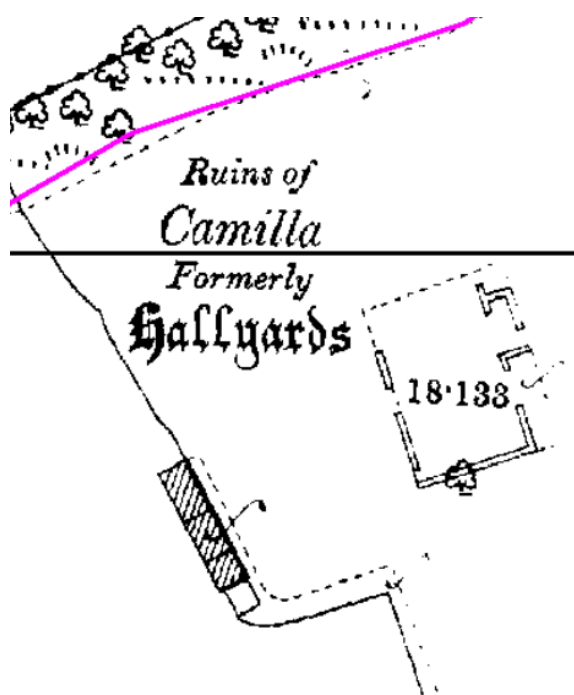
Ruins and farm building in northern area of the site

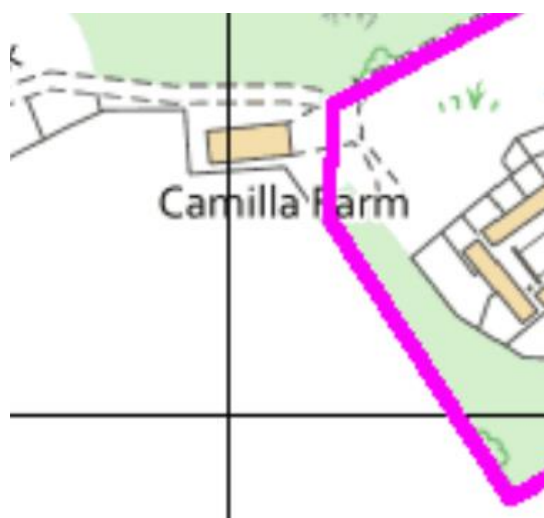
Farm building in south-eastern area of the site

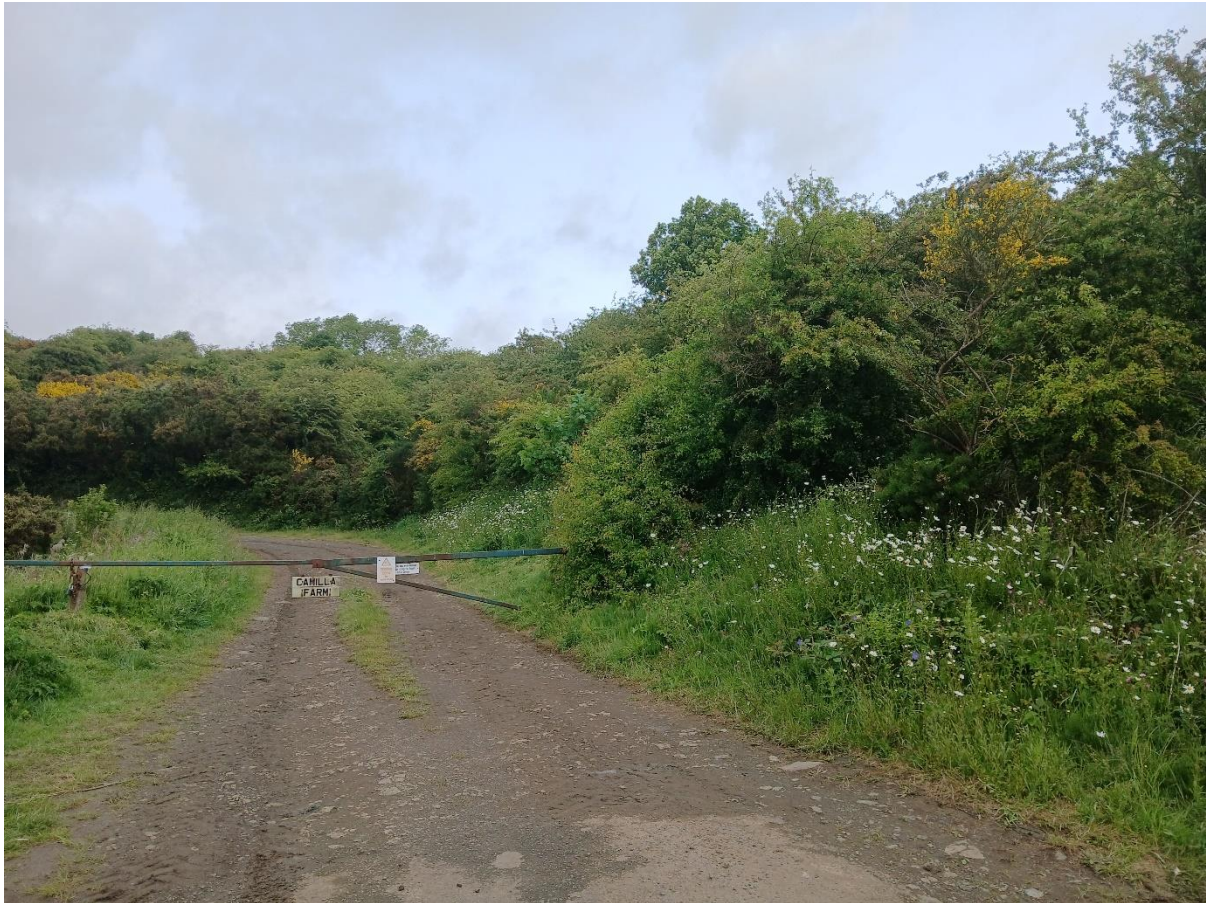
**Plate 1:** View of track up to Camilla Farm from single track road on the southeast of site boundary.

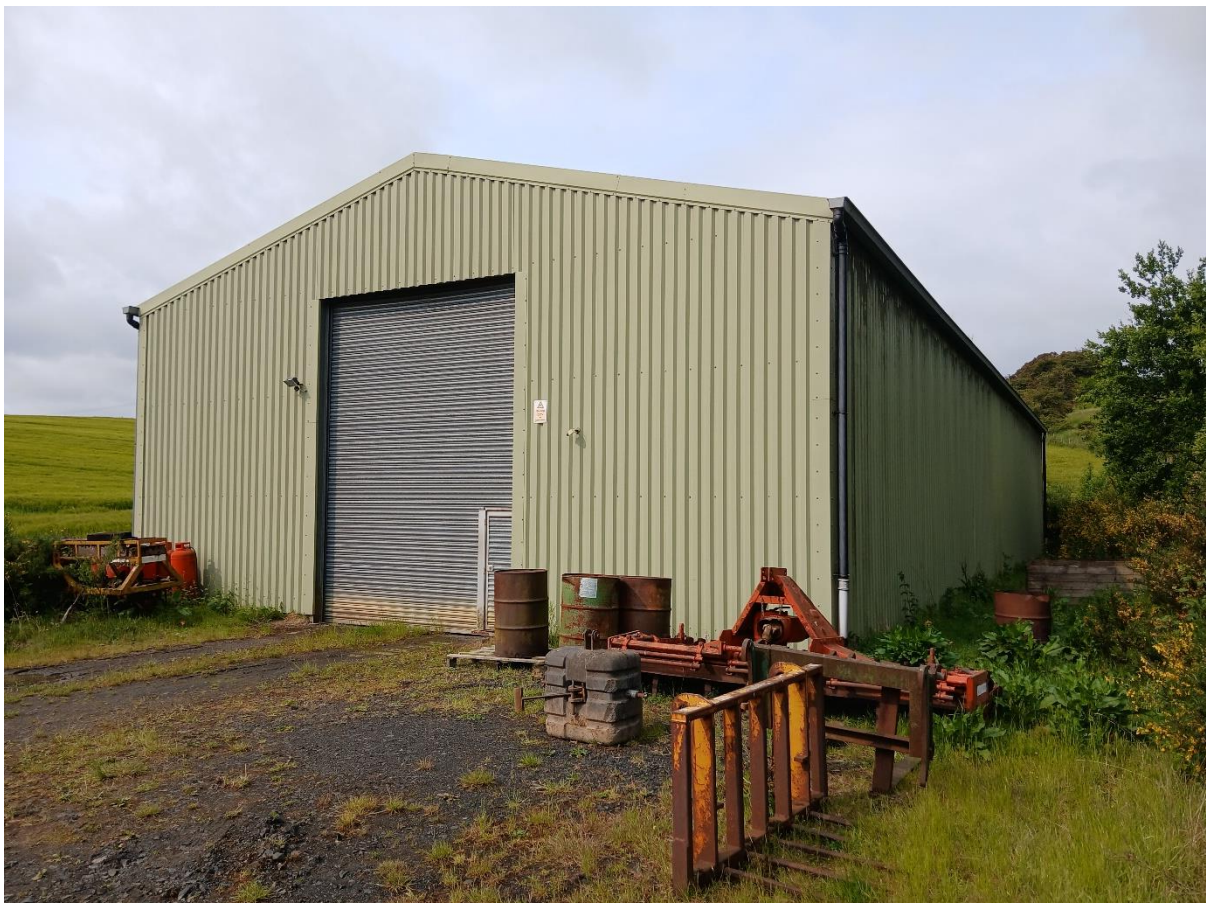
**Plate 2:** Photo looking at Metal barn associated with Camilla Farm in the southeast of site.

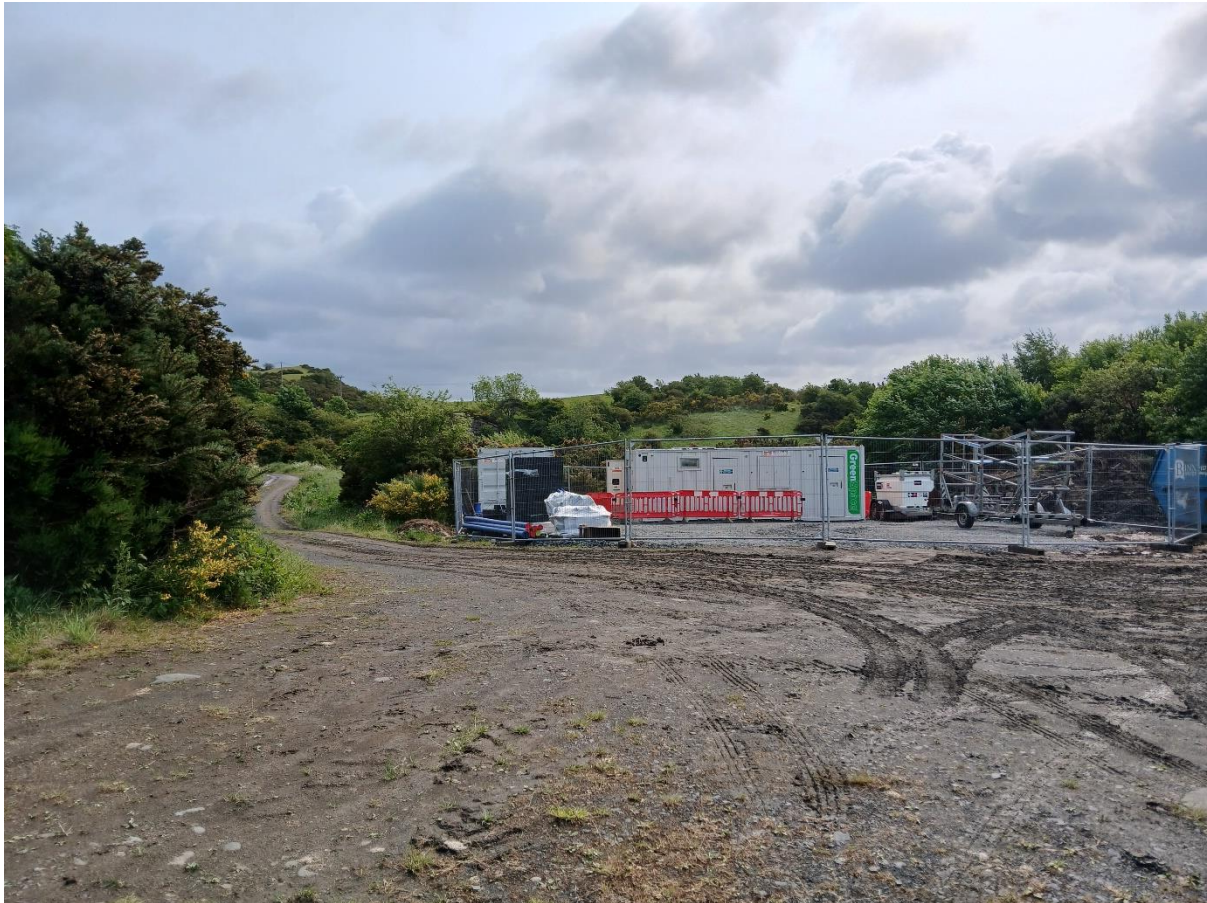
**Plate 3:** View looking east looking over Camilla Farm with construction compound noted east of the barn.

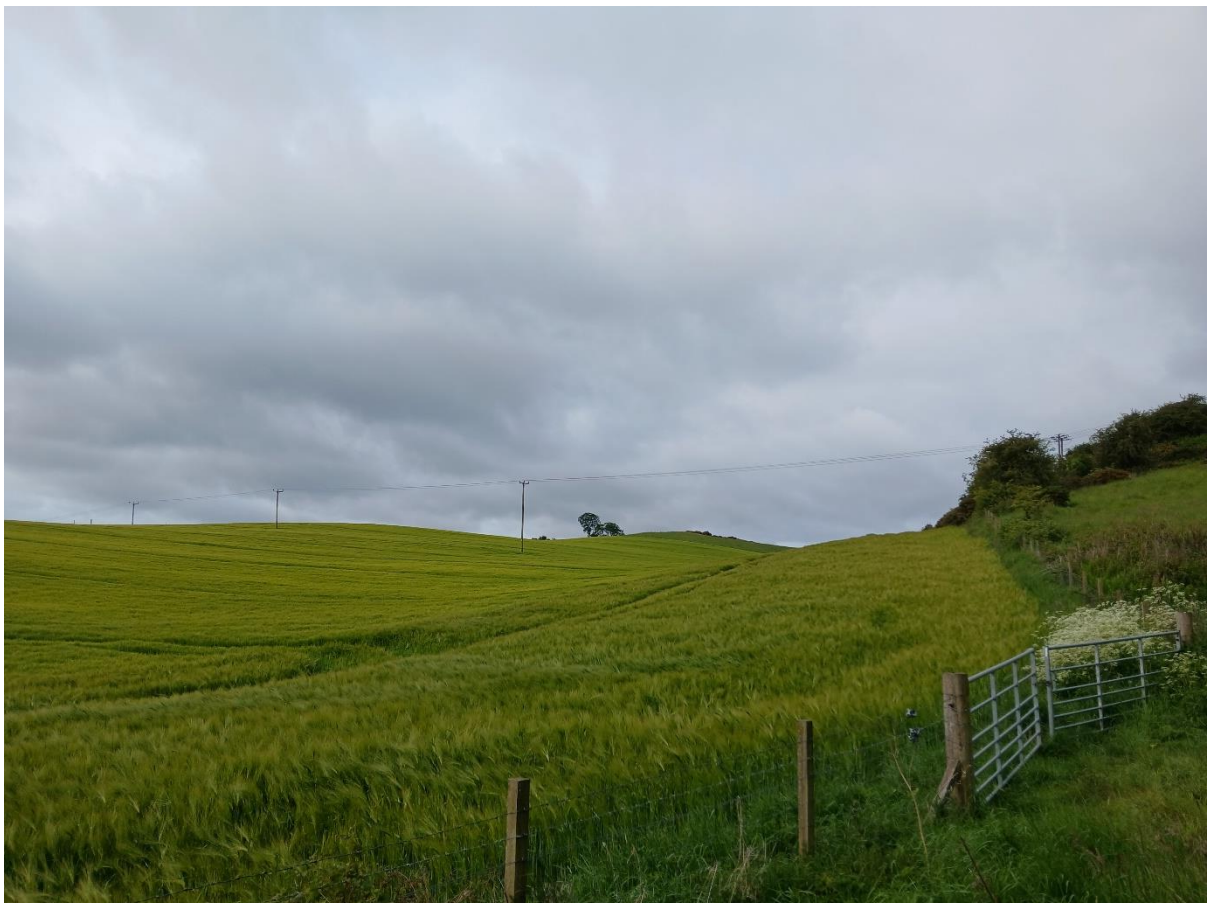
**Plate 4:** View of arable farming field to the south of site with overhead cables running north to south.

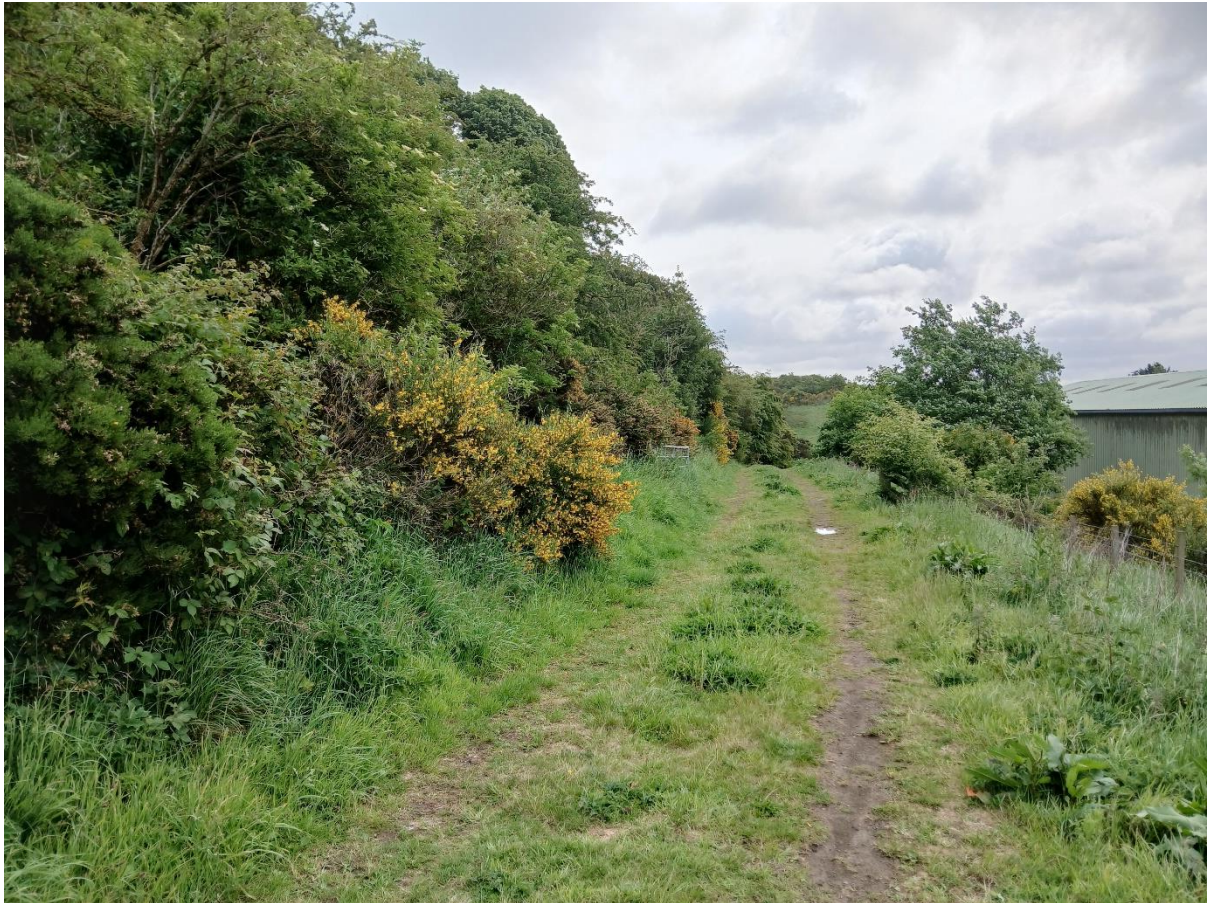
**Plate 5:** Photo of track running from Camilla Farm towards the centre of site.

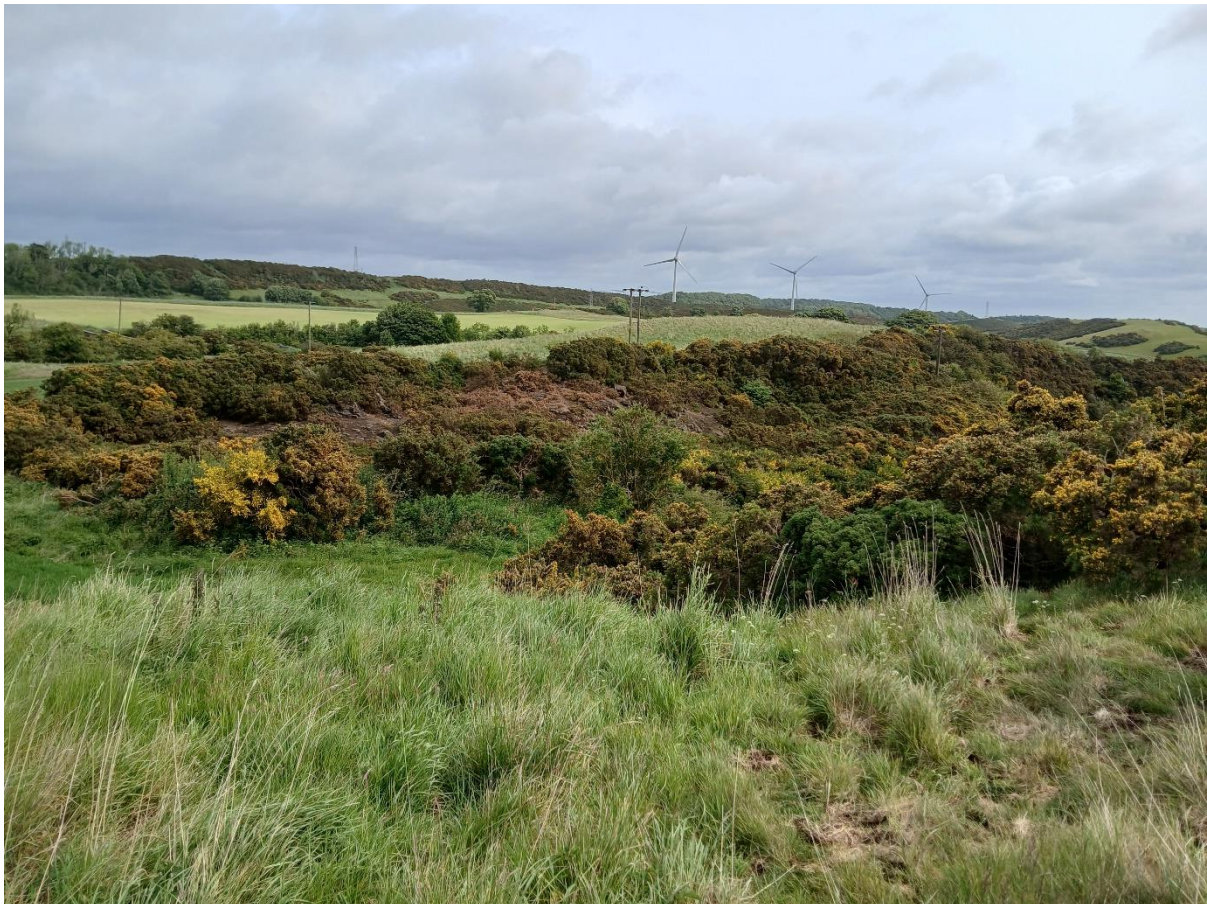
**Plate 6:** Photo looking north through the centre of site showing undulating topography and mixed surface vegetation.

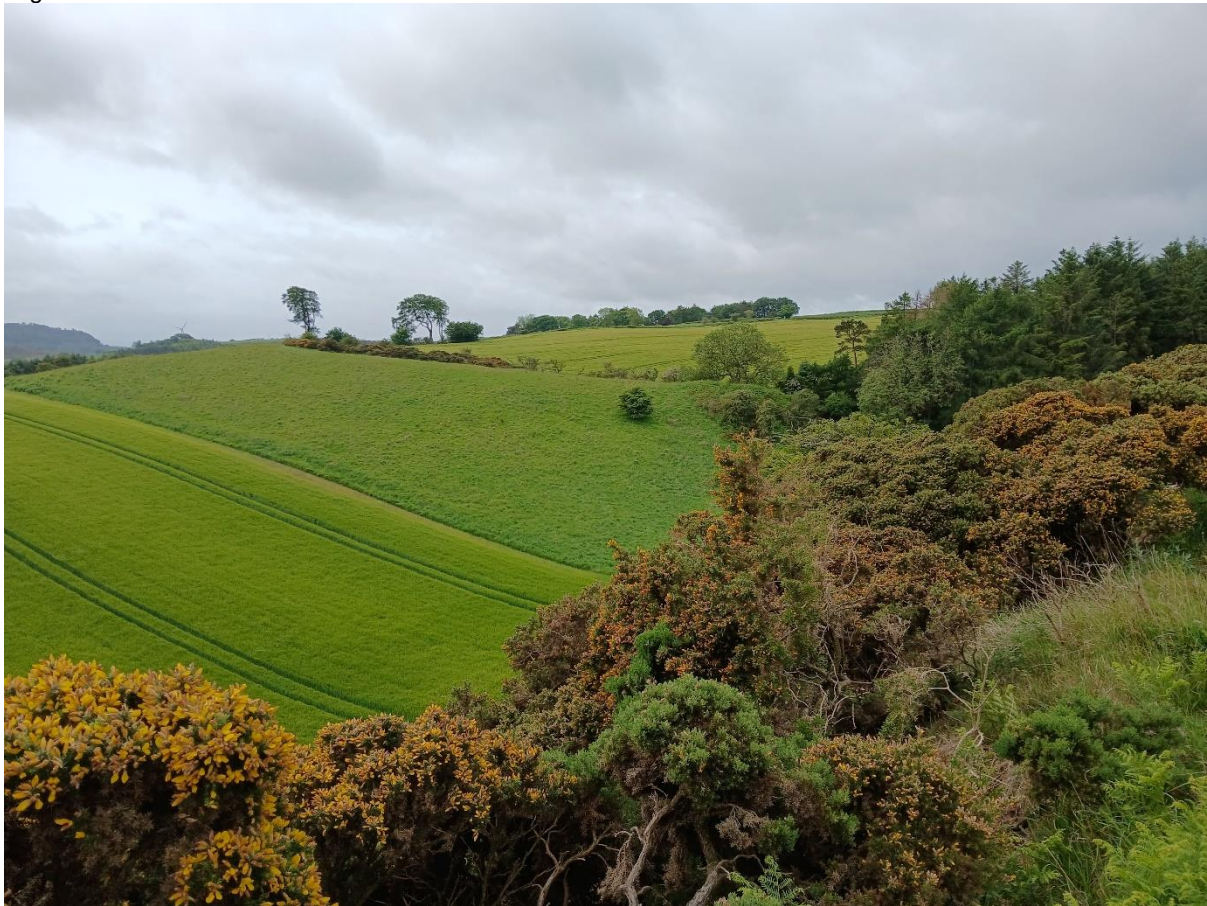
**Plate 7:** Overview of western boundary with steep slopes with dense vegetation growth on.

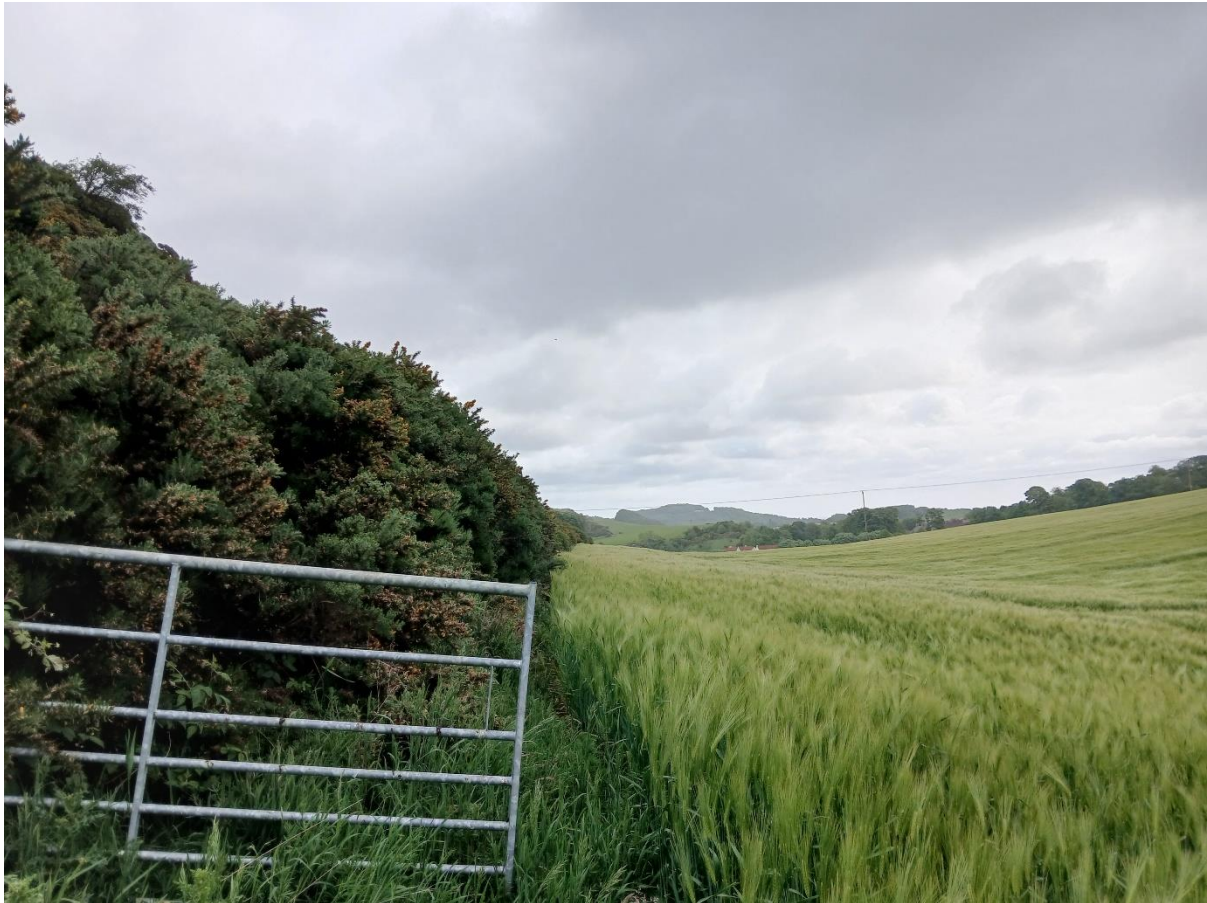
**Plate 8:** Photo of steep slope in the south of site looking east showing arable farming fields.

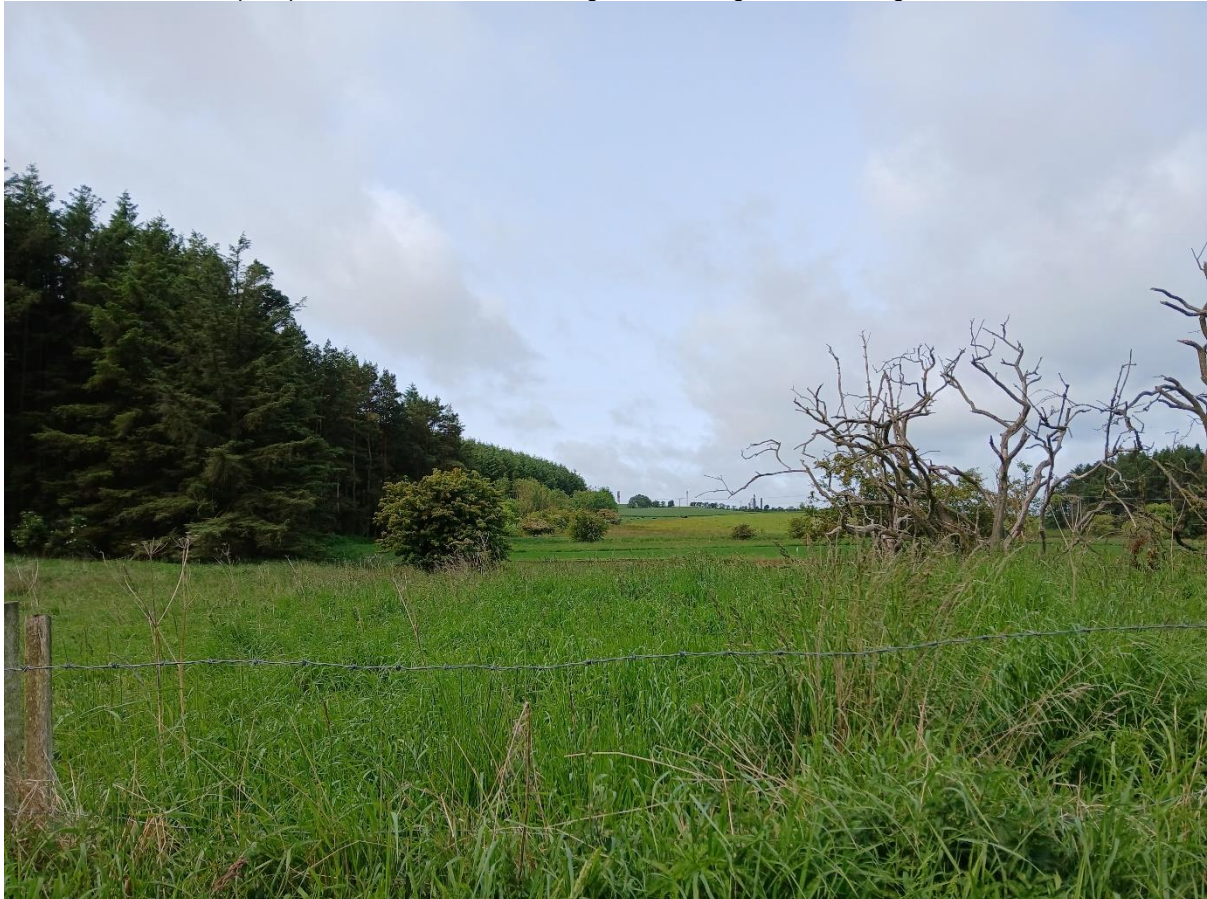
**Plate 9:** Photo of western site boundary looking north.

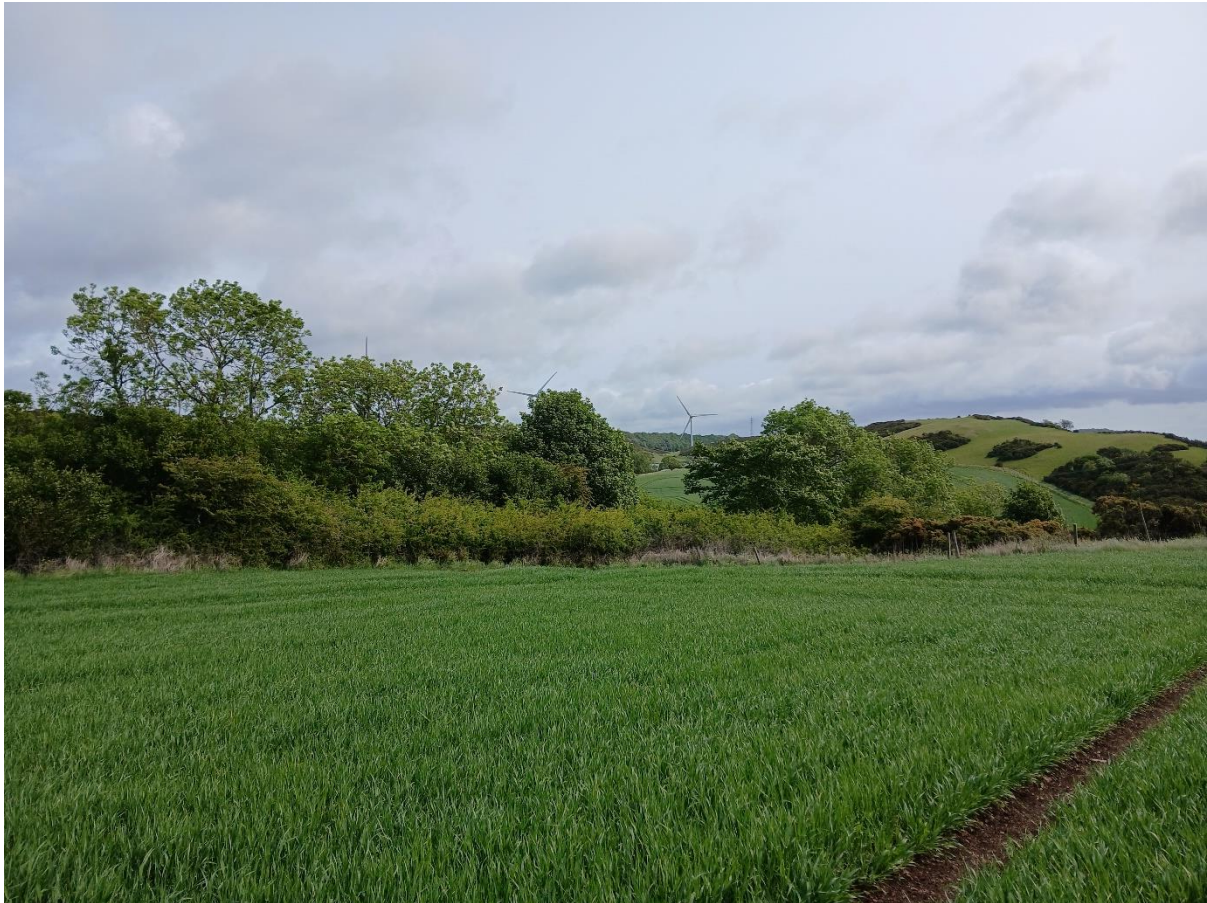
**Plate 10:** Photo of arable farming within the centre of site looking northeast.

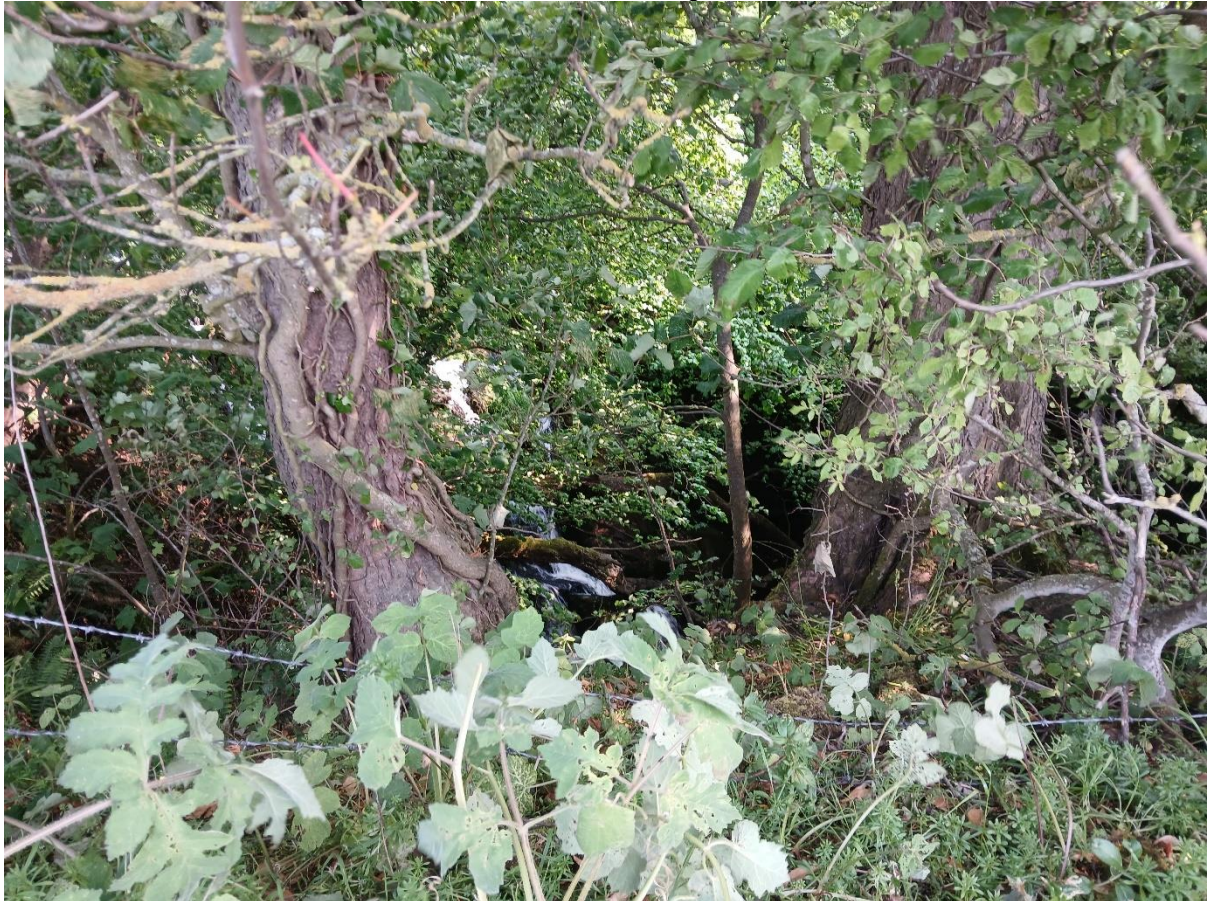
**Plate 11:** Photo shows waterfall feature (centrally) in east of site with steep slopes and dense vegetation growth.

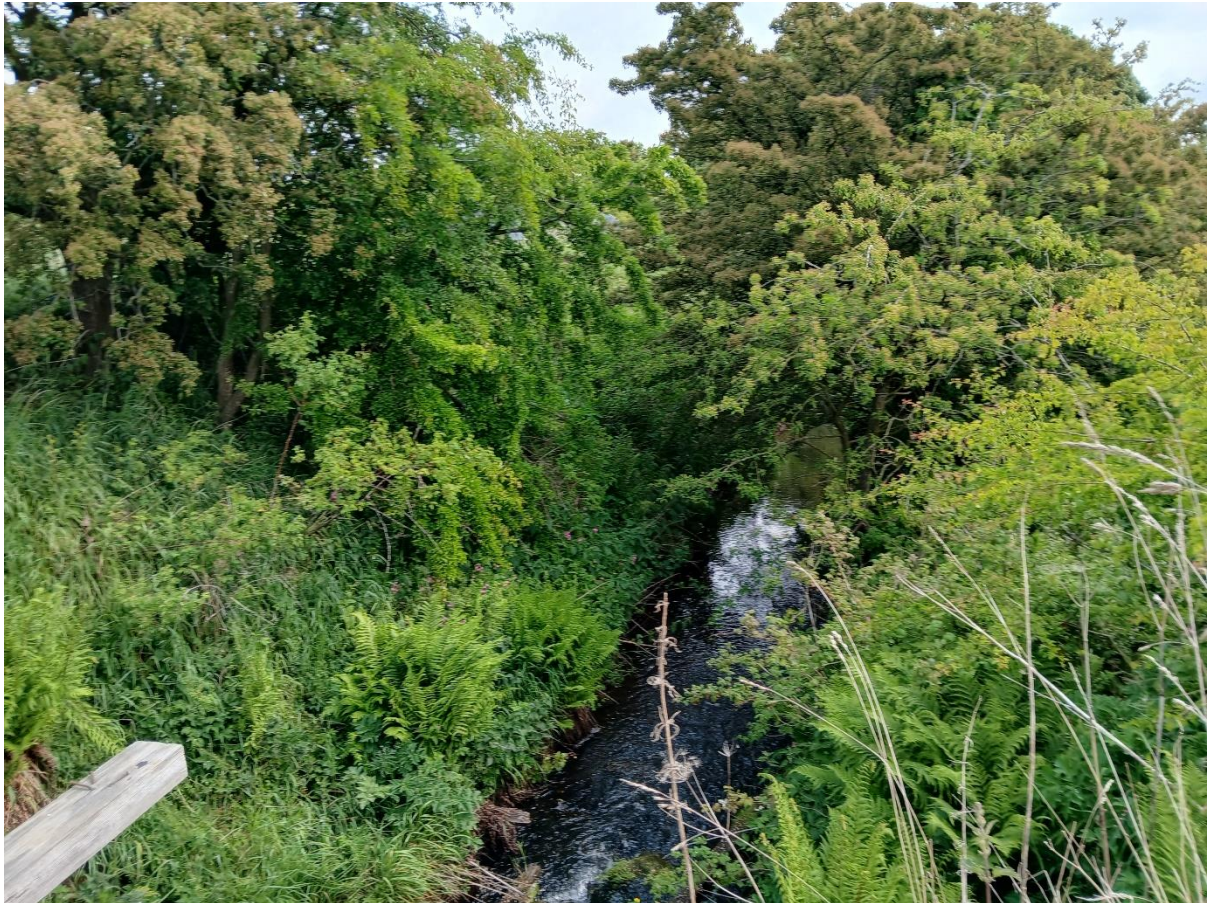
**Plate 12:** Photo of Dronachy Burn flowing through the centre of site, flowing west to east.

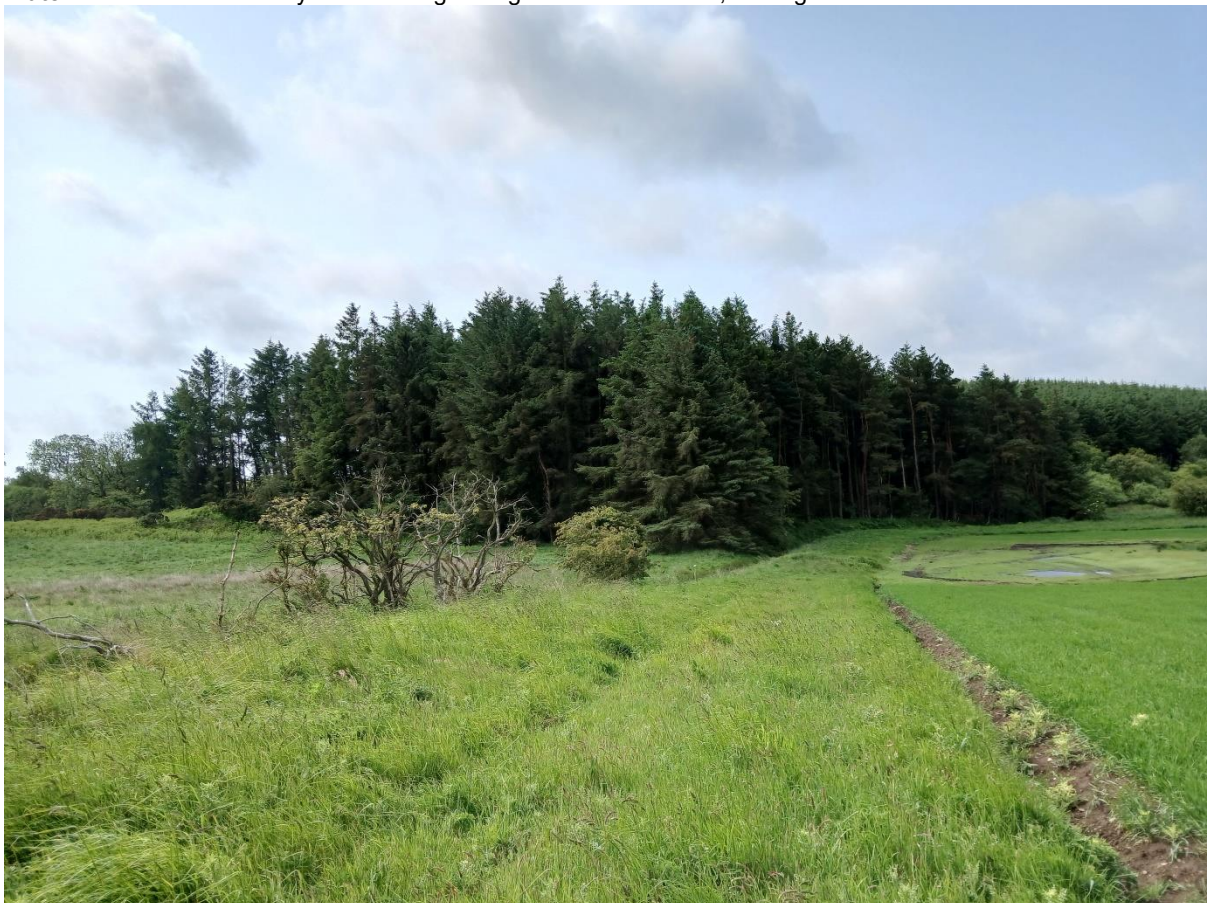
**Plate 13:** Photo looking west along Dronachy Burn towards dense forest on western boundary of site.

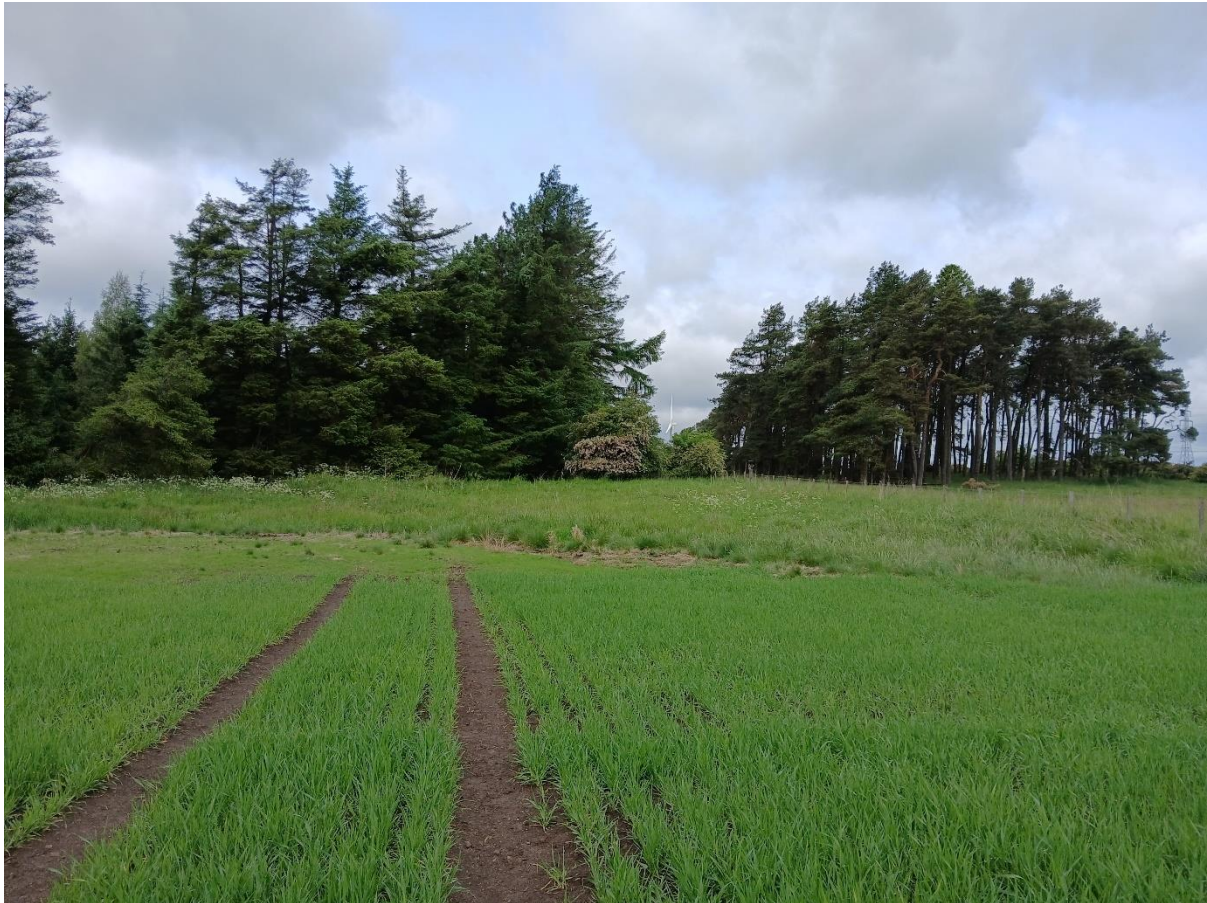
**Plate 14:** Photo looking at western site boundary showing dense forest plantation seen on the western boundary.

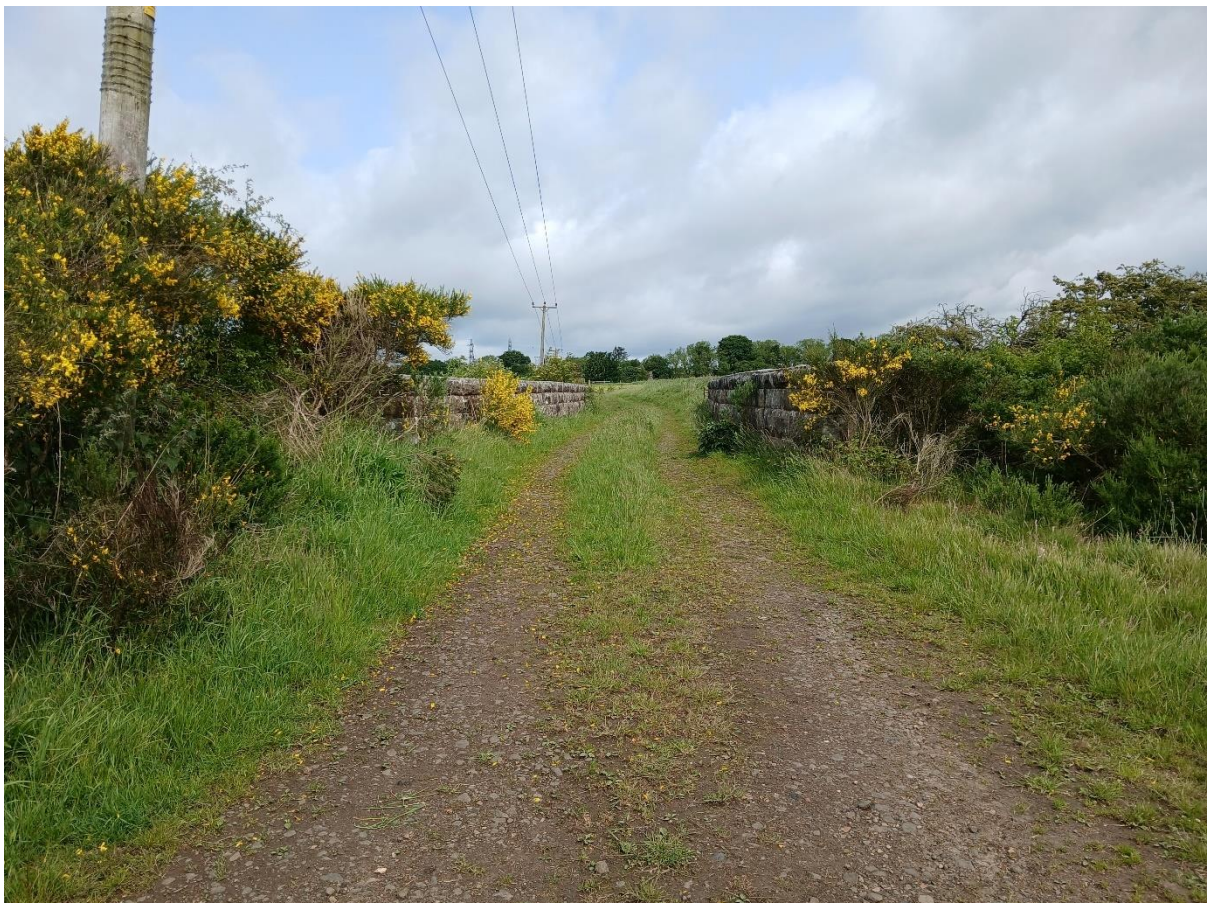
**Plate 15:** Photo looking north showing bridge that may have been associated with the historical railway.

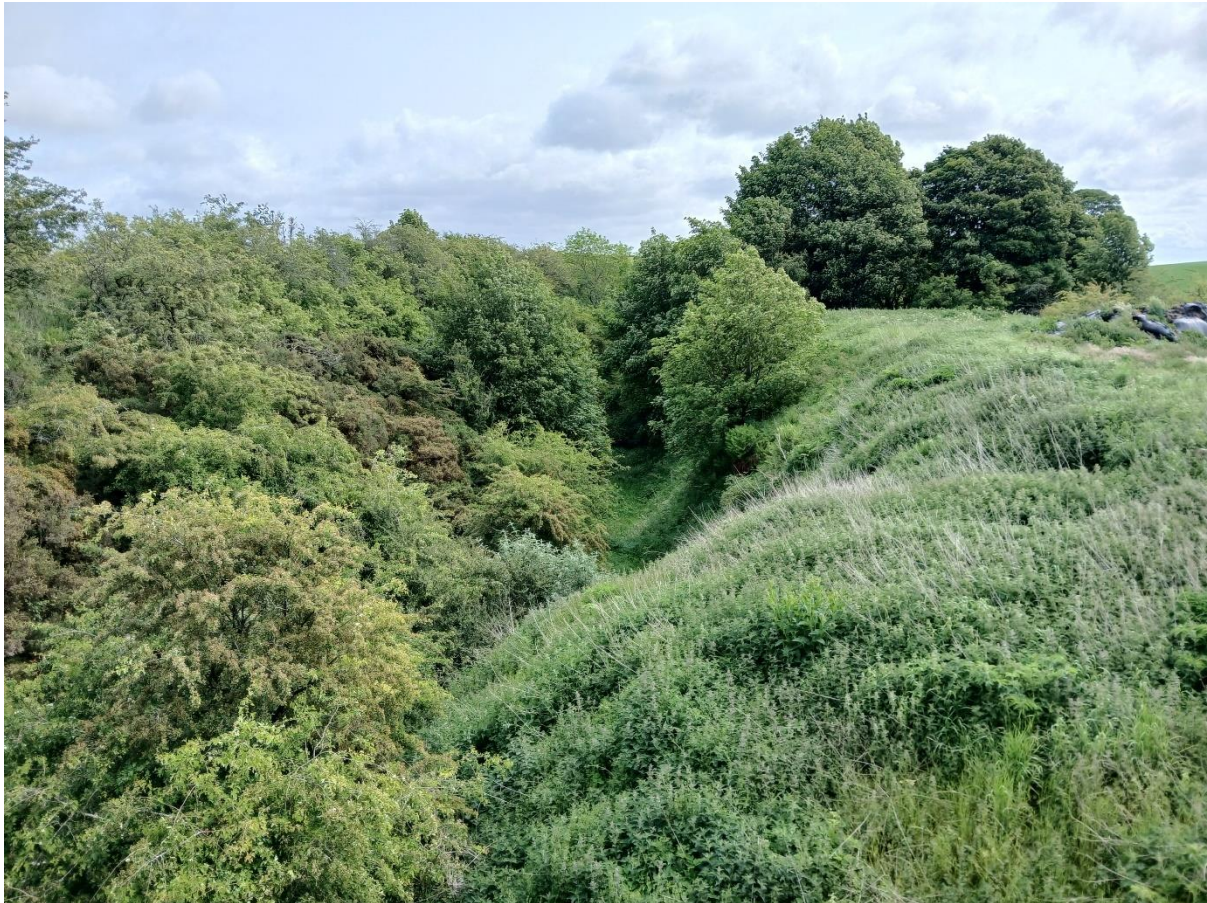
**Plate 16:** Image showing deep verges/cutting to the east of historical bridge possibly associated with historical railway.

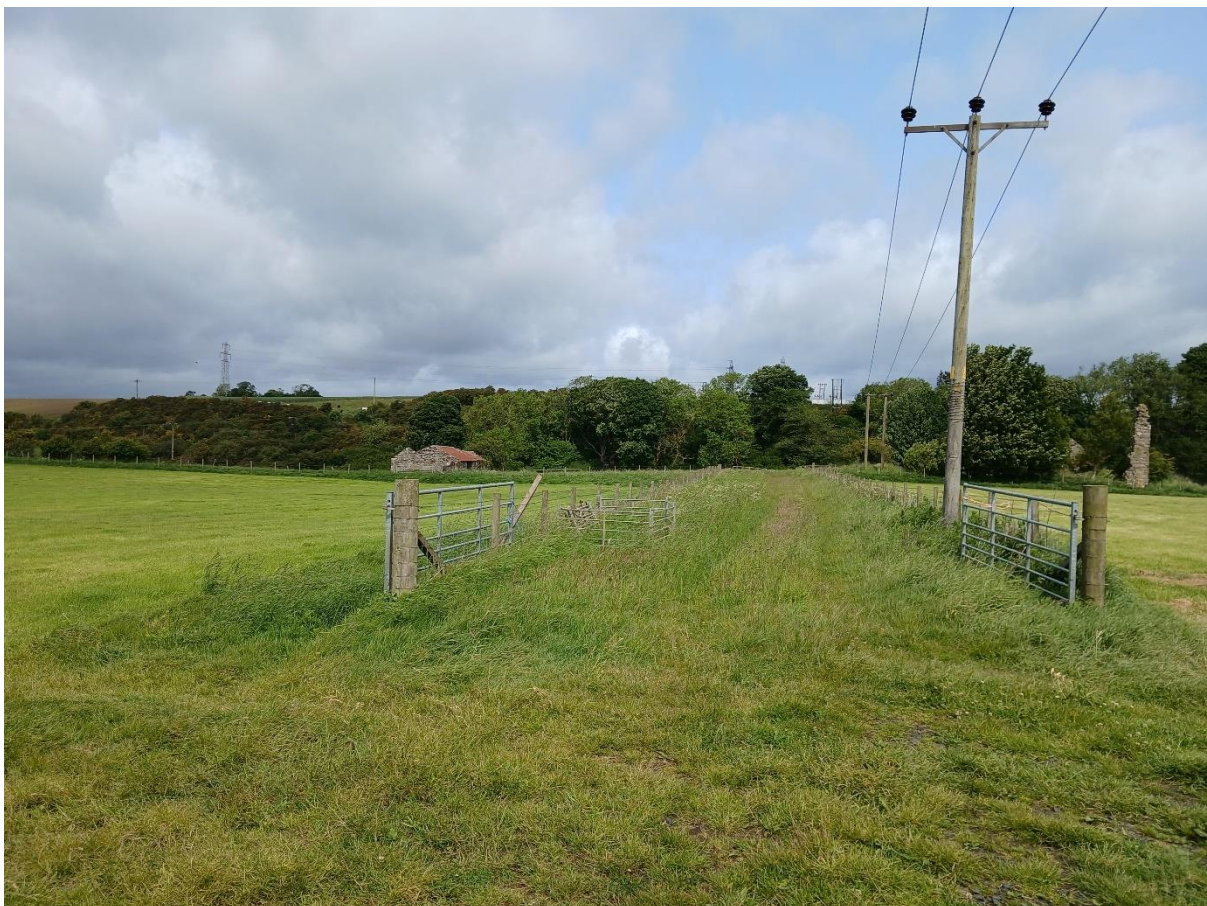
**Plate 17:** Photo looking north showing overhead cables running north to south through site.

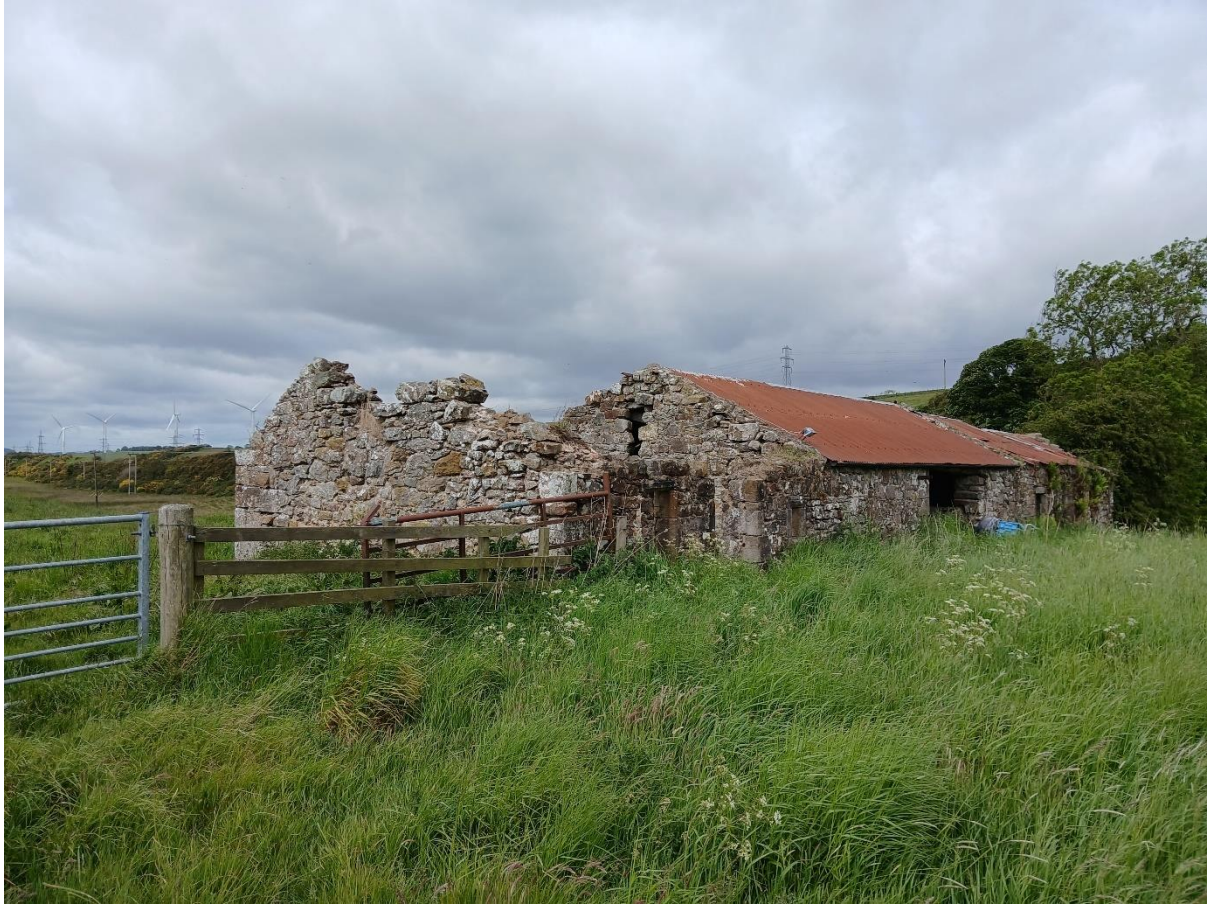
In the centre of the northern boundary an abandoned farm building (possibly old stables) was present. Adjacent to this is what appears to be a monument with evidence of a historical building with some stone walls and foundations still present. A track is seen to run from this building to the east towards the single-track road that runs along the eastern boundary.

**Plate 18:** Image of abandoned farm building seen in the north of site.

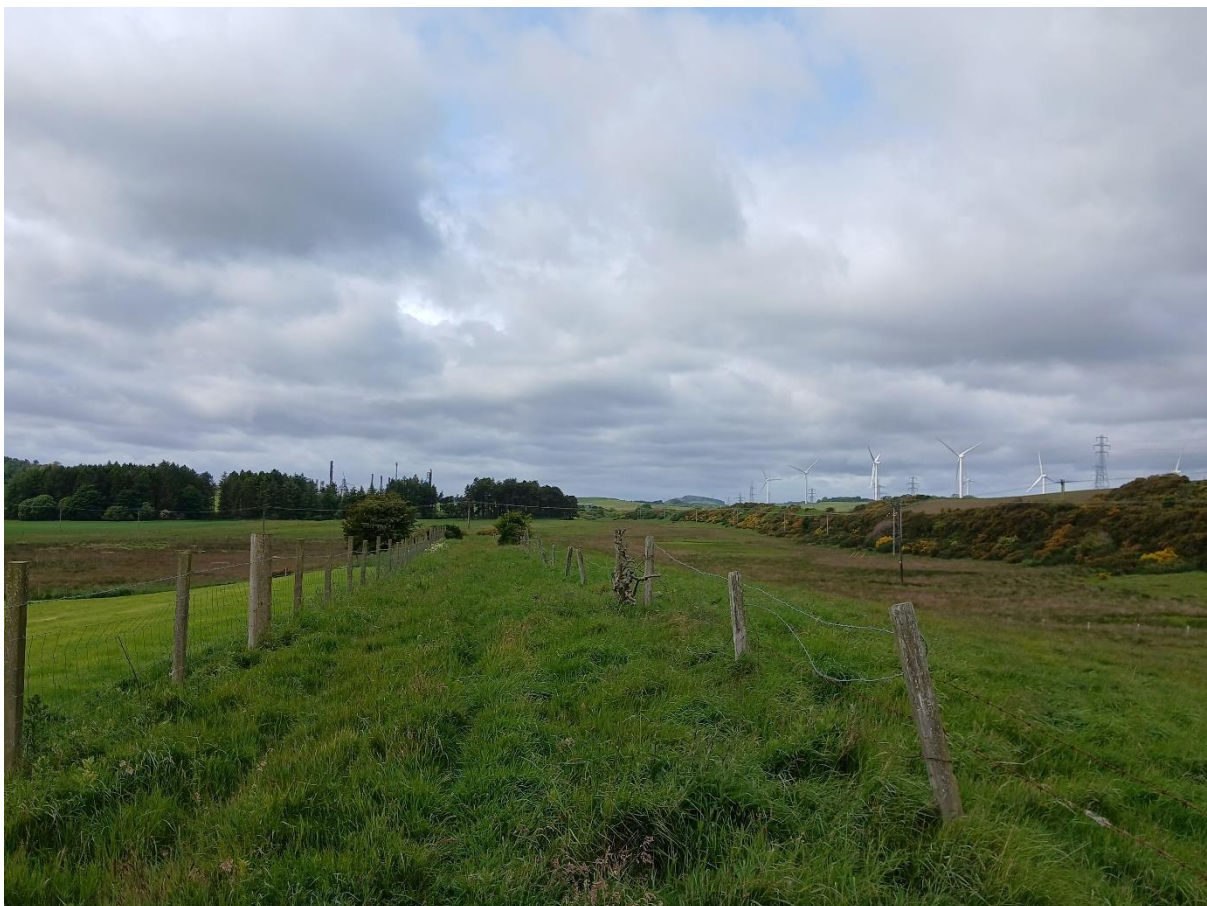
**Plate 19:** Photo looking west along northern boundary showing a small area of dense forest to the west of site.
