## AUCHTERTOOL, MOSSMORRAN, FIFE

### STAGE 1 GEOENVIRONMENTAL INVESTIGATION REPORT INCORPORATING COAL MINING RISK ASSESSMENT (CMRA)

Our Ref: ZG116-01/DOP/SAG/TNO

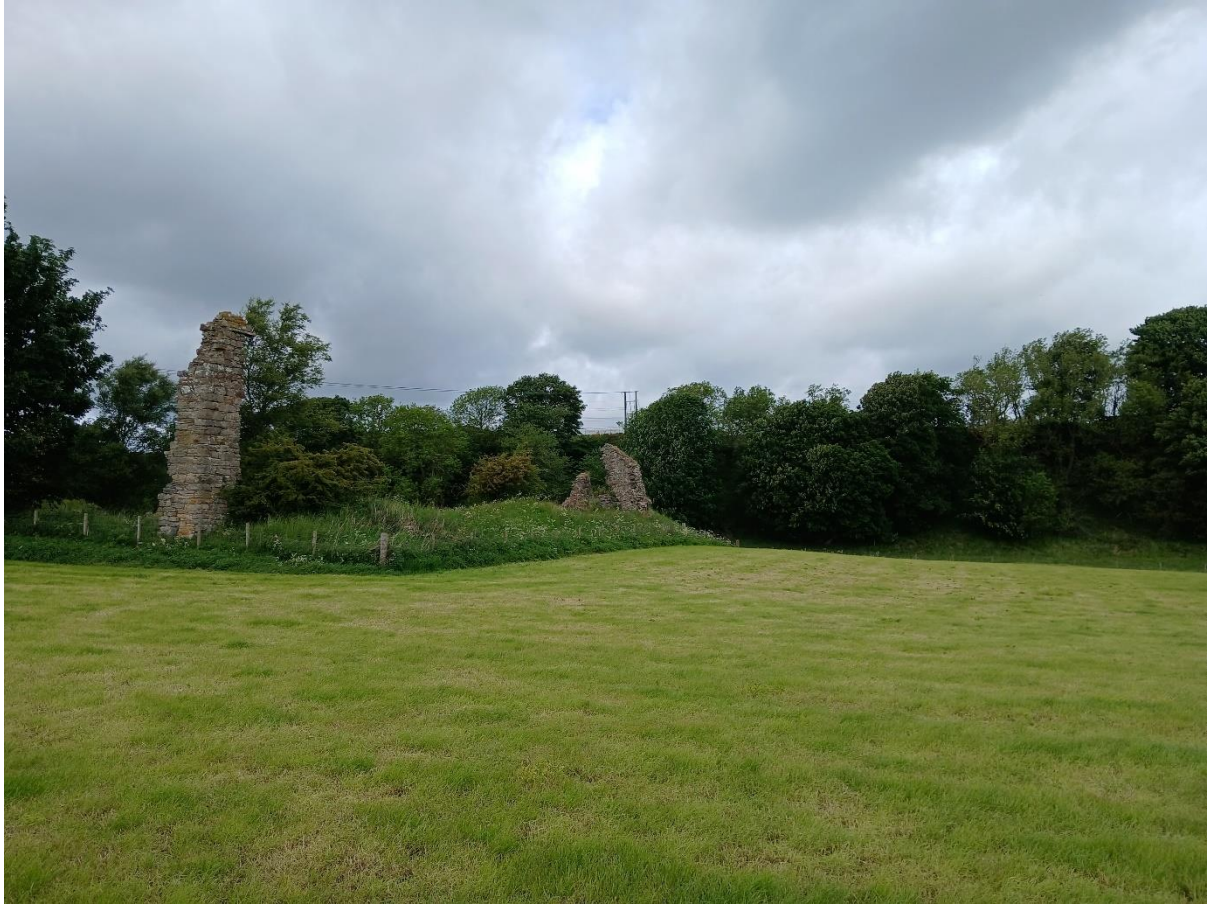
In the centre of the northern boundary an abandoned farm building (possibly old stables) was present. Adjacent to this is what appears to be a monument with evidence of a historical building with some stone walls and foundations still present. A track is seen to run from this building to the east towards the single-track road that runs along the eastern boundary.

**Plate 20:** Photo showing derelict monument seen to the north of site adjacent to the abandoned farm building.
